MARITIME HERITAGE MINNESOTA

Lake Minnetonka Nautical Archaeology 5 Project Report

Results of the Lake Minnetonka Nautical Archaeology 5 Project

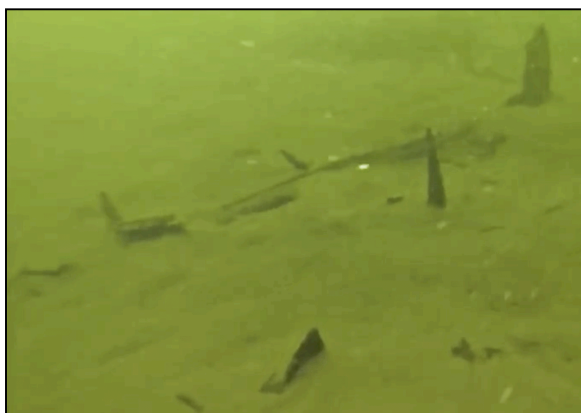
Looking toward the bow of the Wooden Sloop Wreck from the starboard side. The pieces of wood protruding from the lake bottom are the wreck's frames. The gunwale has not survived (Kelly Nehowig).

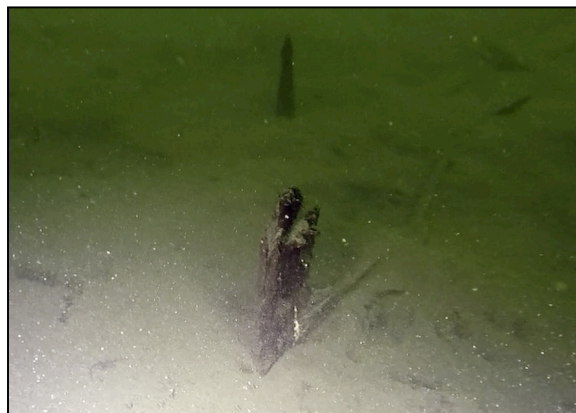
Looking toward the stern of the Wooden Sloop Wreck from the bow. The large stanchion protruding from the lake bottom at the bottom of the image is the stempost. The other stanchion near the top of the image is the stump of the mast (Mark Slick).

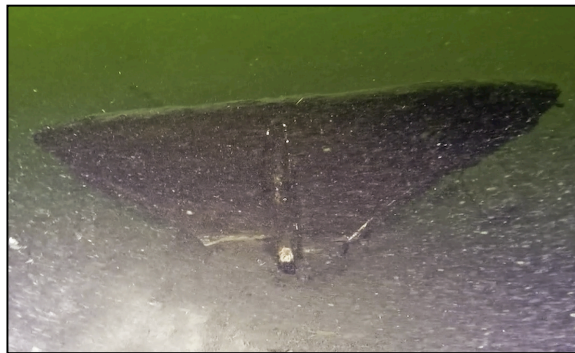
The out transom and the rudder post. This attribute, along with the mast stump, confirm the Wooden Sloop Wreck is a sailboat (Mark Slick).

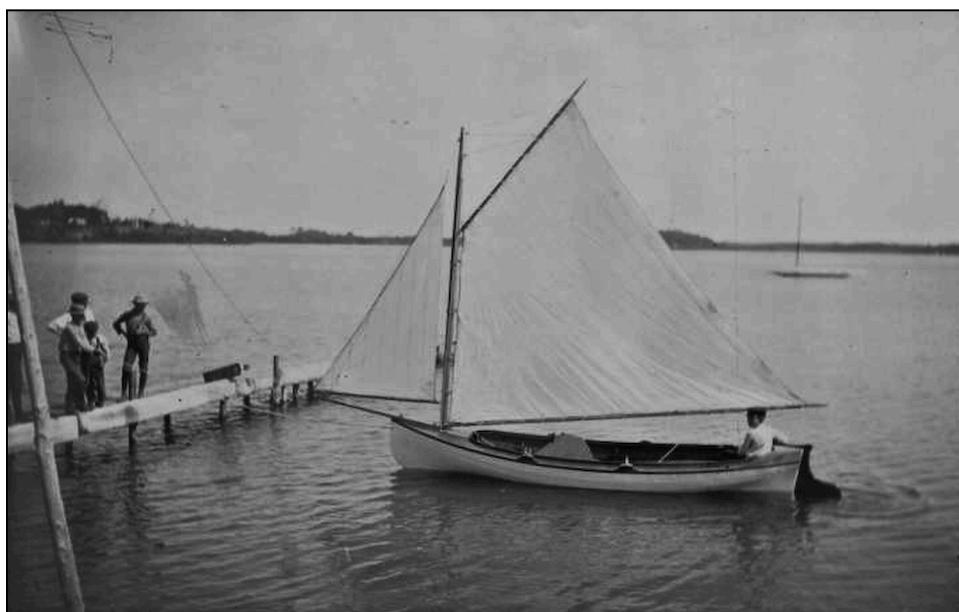
A clinker-built wooden sloop constructed by Moore Boat Works of Wayzata (courtesy of the late Kerm Stake, a friend of MHM).

MHM recorded a sonar image during the LMS-1 Survey in 2011 and it was labeled as Anomaly 488. The Wooden Sloop Wreck may have been constructed by the Moore Boat Works of Wayzata, the major producer of wooden sailboats in the late 1800s on the lake. A sailboat appears in Moore's 1908 catalog, advertised as an augmented family rowboat, but this vessel is depicted with a Bermuda sail instead of the required gaff sail. A sloop is defined as a single-masted sailing vessel, carrying one gaff (trapezoidal) sail and fitted with a bowsprit and optional jib. MHM is confident the Wooden Sloop Wreck is a sloop based on the mast placement. MHM considered the possibility that the wreck could be a catboat, but the mast of a catboat is placed just behind the stempost as far forward as possible. The Wooden Sloop Wreck is the first sailboat wreck identified on the bottom of Lake Minnetonka.

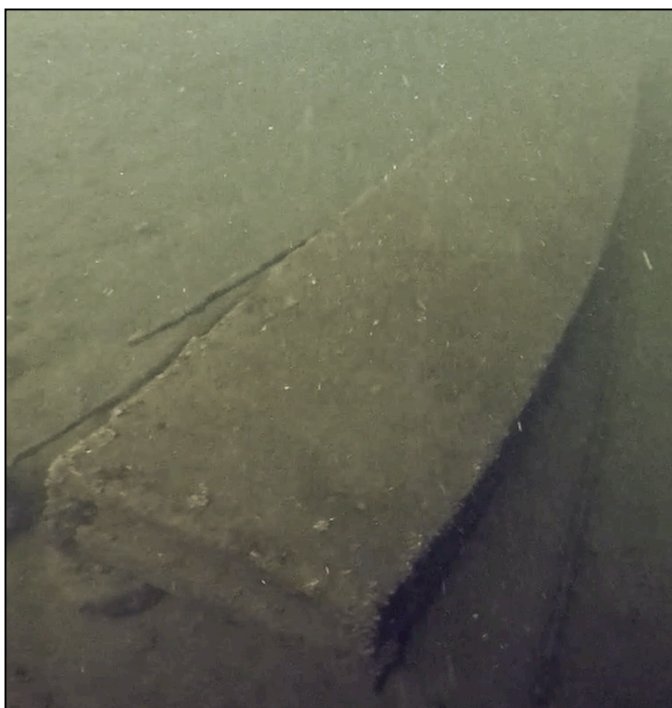
Views of the capsized Fisherman's Friend Wreck from the stern and the bow (Mark Slick).

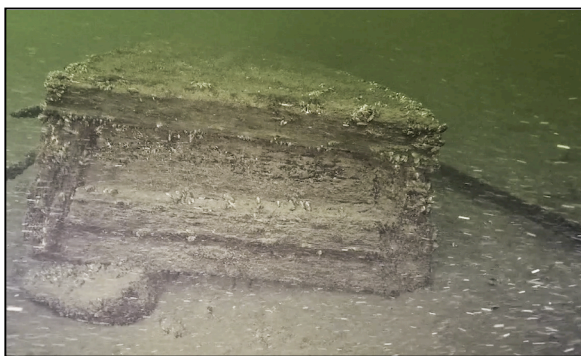
The transom stern of the wreck with a rubrail.

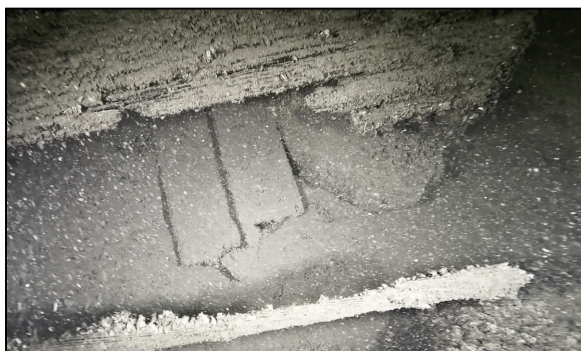
Damage on the starboard stern quarter. The two planks on the lake bottom were attached to the inner hull and served as a stern seat.

medium stone dumped near the wreck site. MHM suggests the boat sank in the area where it functioned as a work boat after it suffered the starboard stern quarter damage. Whether the boat sank accidentally or was scuttled cannot be determined.

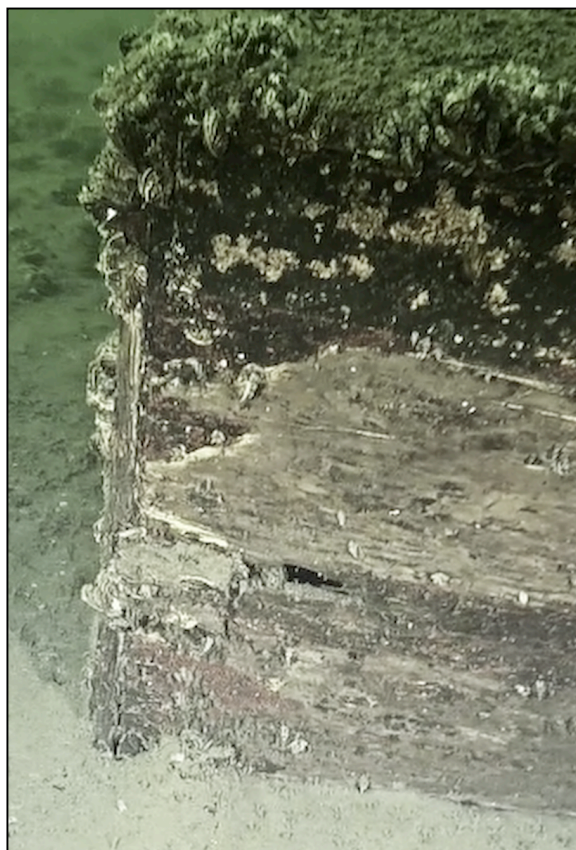
Red paint survives on the port stern quarter.

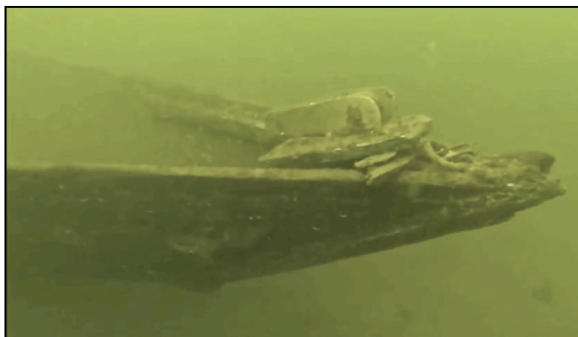
The bow and stern of the Maxwell Bay Rowboat Wreck 2 (Kelly Nehowig).

The tip of the stempost of the sharply pointed bow is damaged and it has a metal ring with an anchor thimble attached. Behind the loop and thimble, an anchor roller with a trapezoidal base plate is loose, but it was once attached between the forward gunwales. Two thin stringers are attached to the upper most strakes on both port and starboard; these beams add forward strength and served as an attachment point for triangular decking that is no longer extant. Amidships, longitudinal two-by-four stringers are attached to the inner hull as supports for a thwart seat that lies loose inside the hull. Thinner stringers are attached to the port and starboard stern quarters inside the hull, on the upper and lower strakes, along with vertical corner braces; again, the upper stringers are supports for a missing thwart seat. Between the amidships and stern seat stringers on port and starboard, two futtocks are attached to the inner hull for support. These futtocks are not true frames since they do not extend across the bottom of the

The most interesting attribute of the Maxwell Bay Rowboat Wreck 2 is the bow's steeply raked design and the composite stempost. The stempost is comprised of two beams, one trapezoidal in cross-section and the other triangular. The trapezoidal piece is set behind the triangular piece and the wreck's strakes are rabbeted into the stempost. Below the stempost, a small bow rub strake is attached to the outer hull. These attributes - the steep rake, composite stempost, and the rub strake - that are put together to form the bow of this small wooden rowboat, combine to make the Maxwell Bay Rowboat Wreck 2 a unique example in the underwater archaeological record of not only Lake Minnetonka, but Minnesota. Beyond their rarity, this combination of attributes are indicators how the boat was operated during its working life; they suggest the Maxwell Bay Rowboat Wreck 2 often landed on shoreline that required a high reinforced bow to absorb the shock of hitting rocks or being dragged along hard ground. The wood of the hull and the main metal components are in exceptional condition. MHM is confident this wreck meets the criteria to be an underwater archaeological site in Minnesota, but some questions remain about specific details of the wreck's construction. MHM will not seek a site designation at this time and further documentation is planned in the near future.

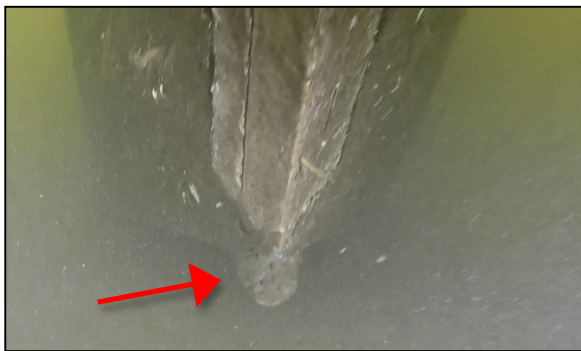
The bow rub strake (Mark Slick).

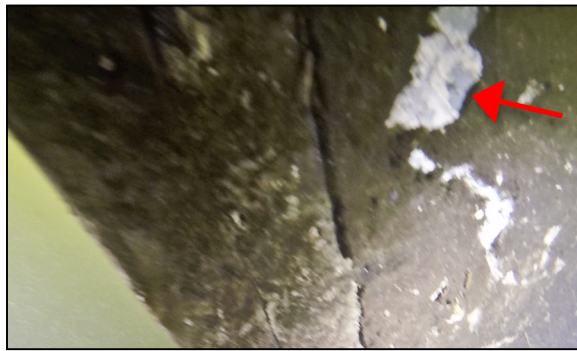
Blue paint with a white undercoating on the port bow (Mark Slick).

hull in the form of floors, but they serve the same purpose as traditional frames. It appears that the hull had layers of paint or primer; bits of light blue paint with a white undercoating are seen on the forward sections of the wreck toward bow.

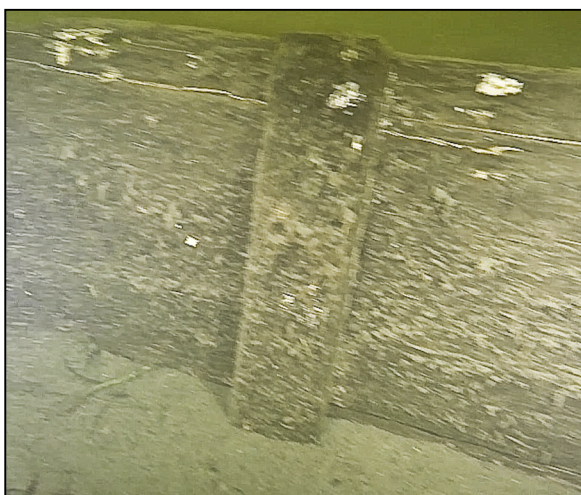
The inner port side hull of the wreck showing a futtock (Mark Slick).

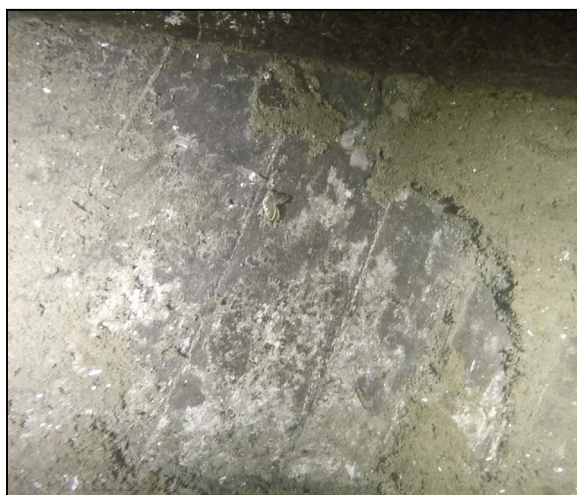
The athwartships bottom planking is clearly seen in this section of cleared bottom hull (Mark Slick).

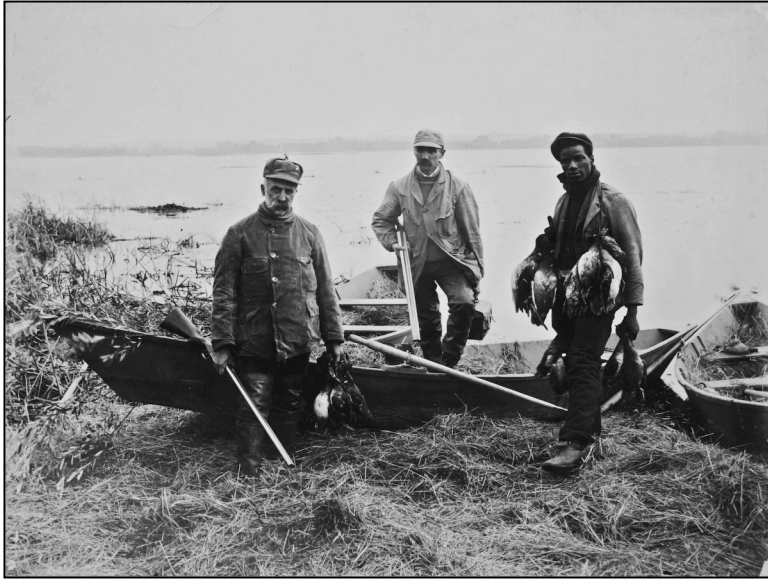
This Minnesota scene of hunters with the birds they shot is valuable to MHM since it shows their boat's bow is similar to Anomaly 78.1. Additionally, it depicts the activity MHM theorizes the Maxwell Bay Rowboat Wreck 2 would have engaged in often - landing on the lakeshore. While the bow of this boat is similar to Anomaly 78.1, the stern is completely different. This photo was taken around 1900 (MNHS GV3.31.p179, digitized by MHM).

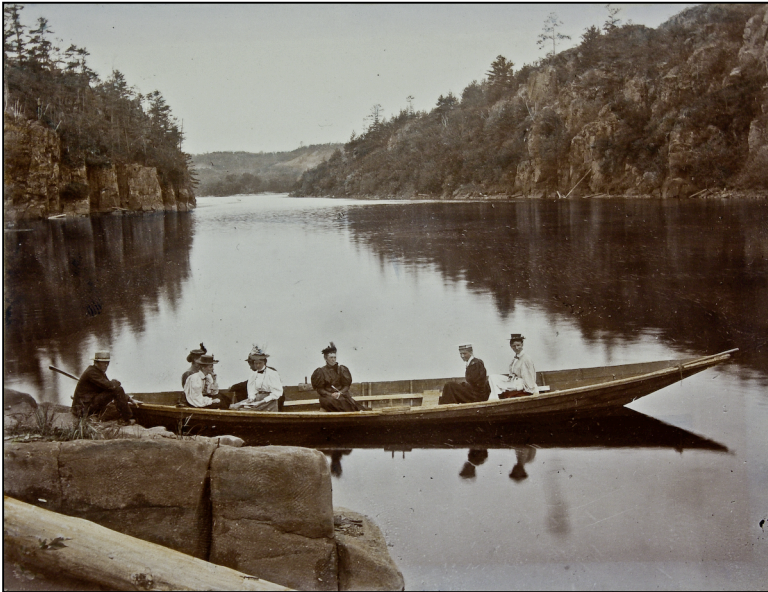
A Minnesota boat that resembles the Maxwell Bay Rowboat Wreck 2, although it is much larger. This photo was taken around 1910 (MNHS GV3.61r45, digitized by MHM).

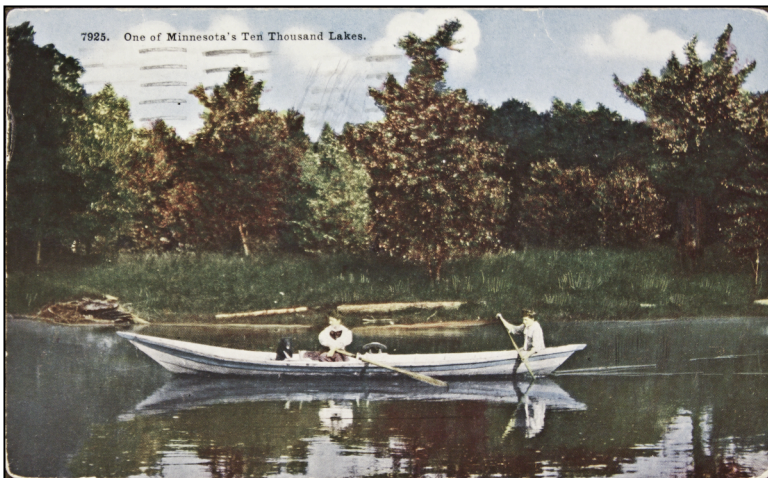
A small Minnesota boat that resembles the Maxwell Bay Rowboat Wreck 2. Note the people in are paddling the boat, not rowing. This photo was taken prior to 1915 (MNHS GV3.61r31, digitized by MHM).

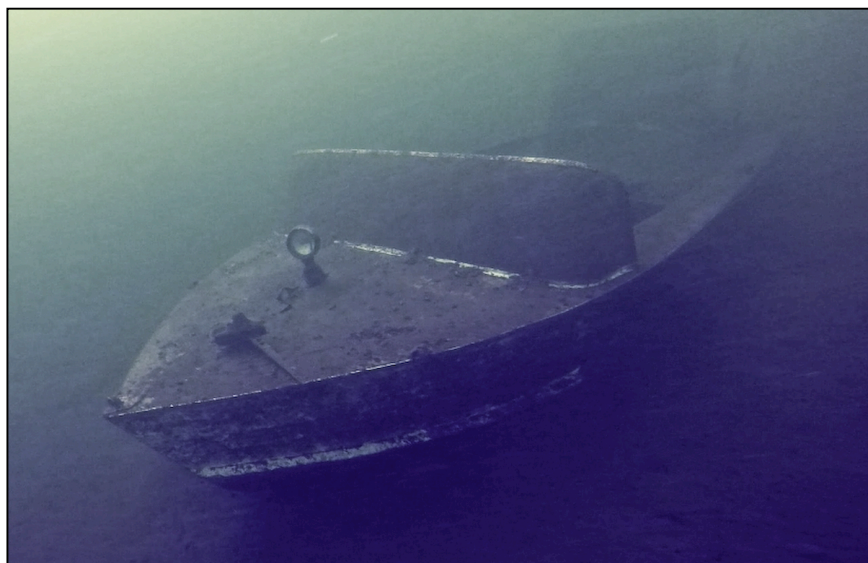
Doug Out, looking from the port bow. The deck fittings, including the fallen Nautalloy navigation lights and pennant mast, Iva-Lite spotlight, windshield, faux lapstrake fiberglass hull, and splashrail are clearly seen (Mark Slick).

MHM recorded a sonar image of the *Doug Out* Utility Wreck (Anomaly 403) during the LMS-1 Project in November 2011. The name of the wreck is derived from her actual name - *Doug Out* - was seen on the stern once silt was cleared away from the hull, under what appears to be an exhaust port. The wreck is 16.00 feet long and 5.50 feet in the beam. She has a fiberglass hull that is formed to resemble a clinker-built wooden boat. The faux-lapstrake design of *Doug Out* is not profound, but it is easily seen on the outer hull and the designer's intention to imitate a wooden boat is obvious. The wreck's forward deck, gunwales, and inner hull are outfitted in wood. The deck is probably mahogany, while the other wooden components may be a combination of mahogany and plywood laminates. Foredeck components include a Nautalloy navigation light with a pennant mast (Andy Mueller, personal communication, 10 December 2015) that has fallen over, towing loop, lifting eye, two chocks, an Iva-Lite spotlight, and the windshield is intact. On the port side amidships, an air vent cowl survives, although it is loose over the hole that allowed air into the bilge; a corresponding starboard hole is seen, but the cowl is missing and may be lying under the silt alongside the wreck or buried inside the hull. On the port and starboard side stern quarters, another set of chocks are attached to the gunwale. At the stern, the afterdeck is outfitted with a gas tank cap, stern lifting eye, and a short light mast that is still up, indicating the boat may have been traveling in the dark when she sank. A water ski pull is attached to the wreck. It lies on the afterdeck wrapped around the lifting eye, and it terminates at the buoyant ski handles, suspended in the water column at the port stern quarter. A thinner line runs from the stern lifting eye through the port side stern chock and into the hull. A splashrail extends from the bow on port and starboard at least 3/4 of the way down the hull, and possibly the entire wreck. A splashrail that extends the full length of a hull is most commonly found on aluminum boats, not fiberglass examples.

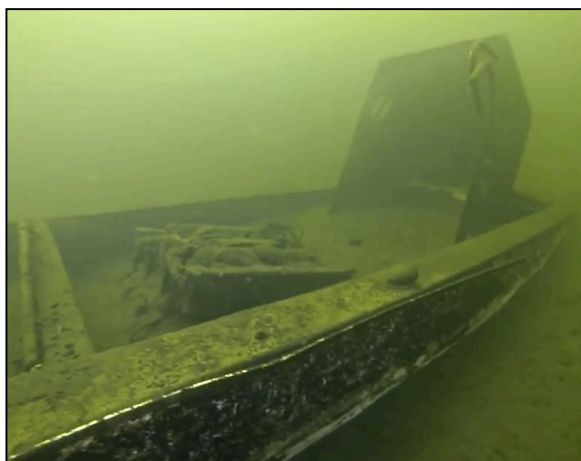
The port side of the wreck showing the splashrail, engine, and the doghouse flipped open (Kelly Nehowig).

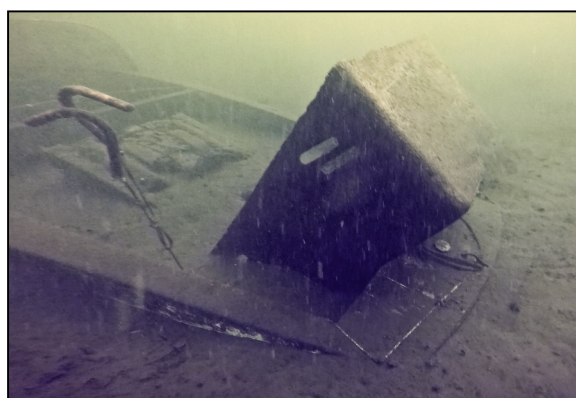
Viewing the wreck from the port quarter stern, the ski pull handles are seen in the water column. The gas cap is seen on the after deck under the doghouse along with more of the ski pull (Mark Slick).

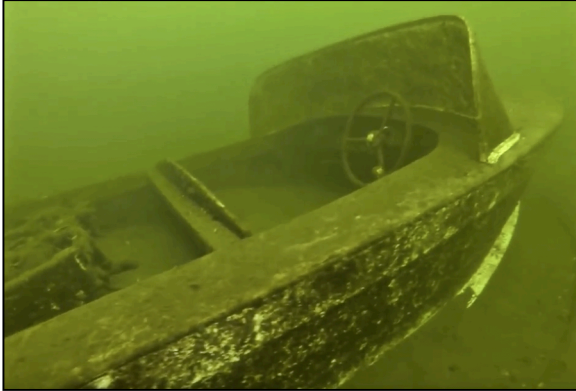
The starboard side looking toward the cockpit, dashboard, and windshield (Kelly Nehowig).

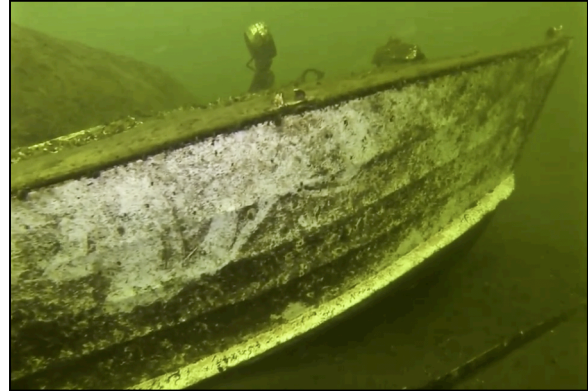
The starboard forward quarter showing the faux lapstrake hull and deck fittings. The lack of a registration number means *Doug Out* sank prior to July 1, 1959 (Kelly Nehowig).

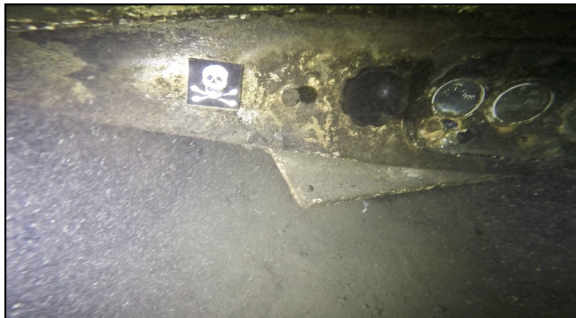
The dashboard of the wreck with gauges to the right, then the Iva-Lite knob, and then the skull and crossbones icon (Mark Slick).

The wreck has an intact dashboard with the appropriate gauges set in a backing plate. To the port side of the gauges, the Iva-Lite controller extends from the dash and next to that, a rectangular black and white skull and crossbones icon was unexpectedly found. The red steering wheel has white details and a throttle lever, possibly made redundant by the side-mounted Morse controller located on the starboard side inner hull. The cockpit is created by a high-backed bench seat for the operator and a passenger. Just behind the bench, the 8 cylinder inboard engine is visible because the doghouse cover detached and flipped backward during the wrecking process, landing against the transom. Vent holes are seen in the sides of the doghouse. The wreck has no registration number, indicating she sank prior to July 1, 1959. However, one attribute found on the wreck indicate she may have actually sank during the early summer of 1959; the Nautalloy navigation lights and pennant mast were designed by Tom Faul for Harwood Shepard's business, the Aluminum Manufacturing Company "about 1959" according to Shepard's son and contemporary literature (Andy Mueller, personal communication, 10 December 2015; Mtngentleman 2010). MHM has many questions to answer about Anomaly 403, including her year of manufacture and her brand. It is hoped that funding can be secured in the immediate future in order to return to the wreck for more data collection.

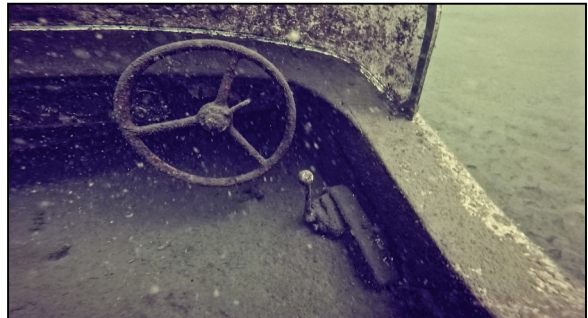
The red steering wheel attached to the dashboard and the throttle controller on the starboard side (Mark Slick).

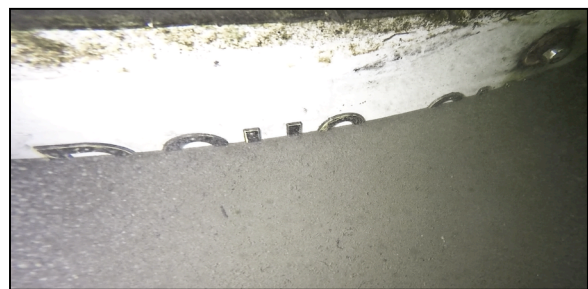
With some of the silt cleared away from the stern, the name *DOUG OUT* is visible and made of raised black letters (Mark Slick).

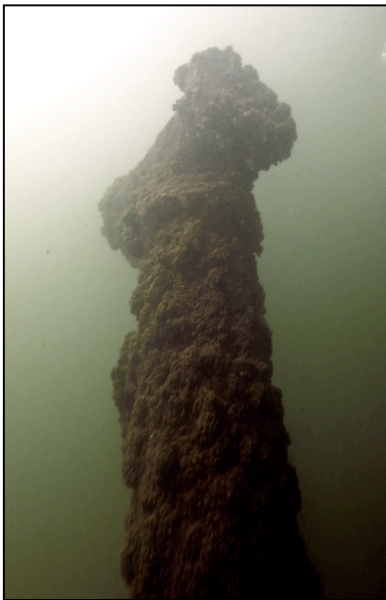
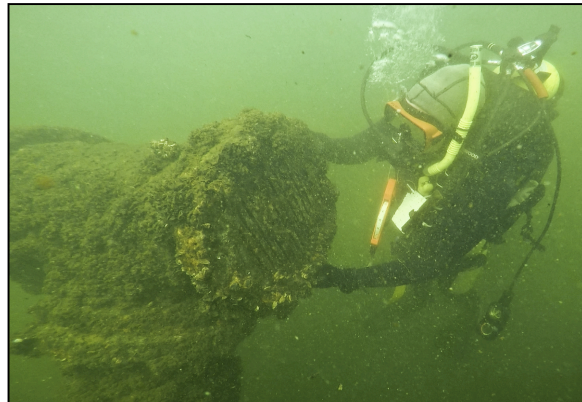
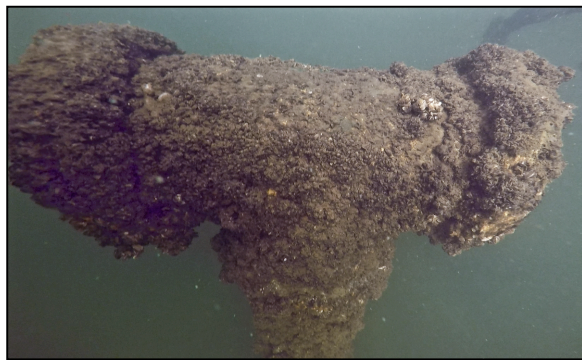
The Water Intake Pipe with the T at its top rises about 15 feet into the water column. The size of the T can be seen compared to MHM's Olson (Mark Slick).

Below: The Wooden Crib, weighed down with stones, that holds the Water Intake Pipe in the water column (Kelly Nehowig).

MHM recorded a sonar image of Anomaly 9 in November 2011 during the LMS-1 Project in November 2011 and dove on the site in early mid-September 2015. The site is a metal pipe shaped like a tall 'T' and anchored to the lake bottom by a stone-filled wooden crib. The pipe stands 15 feet in the water column, each mouth of the 'T' is 2.00 feet in diameter, and the wooden crib measures 5.00 feet by 10.00 feet. MHM's Olson determined the pipe is a water intake. It was extrapolated, then, that a pipe must extend into the lakebed under the crib and toward shore. MHM's sonar footage was reviewed and the acoustical signature of the pipe was found protruding from the bottom silt and disappearing into the shallows near the shore. MHM then dove on the exposed pipe in mid-October 2015. The 8-inch diameter pipe appears out of the silt about 66 feet southeast from the crib and is visible for about 64 feet, disappearing into the lake bottom at the weed line. MHM suggests the water intake, as part of Lake Minnetonka's maritime infrastructure, supplied water to the Minnetonka Beach water tower when it was constructed in the 1920s (Heidi Honey, personal communication, 22 December 2015). The intake pipe and crib, along with the pipe along the lake bottom, are directly in line with the water tower. Anomaly 9 is covered in zebra mussels, the metal pipe more profusely covered than the wooden crib and stones. The Water Intake Pipe and

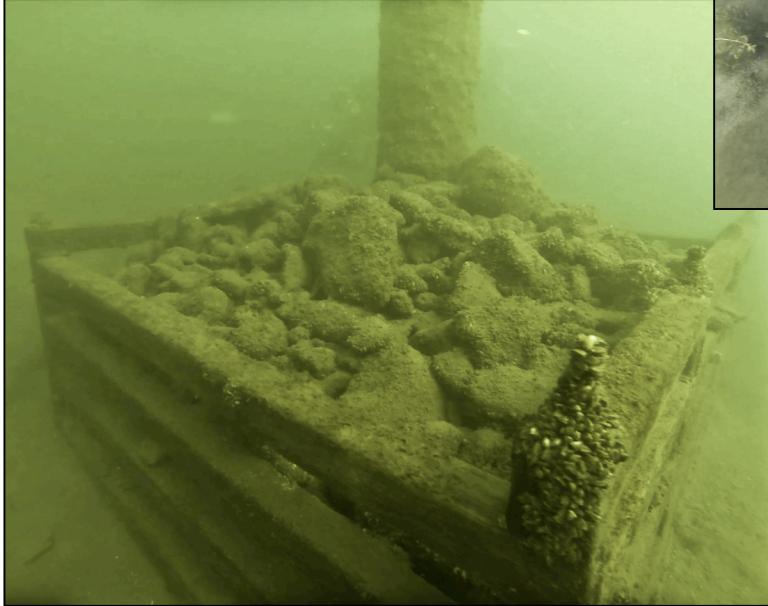
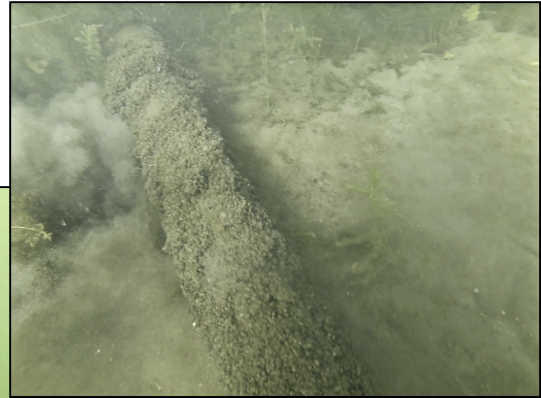
Above: The Intake Pipe lying on the lake bottom where it disappears into the weedline in shallow water (Kelly Nehowig).

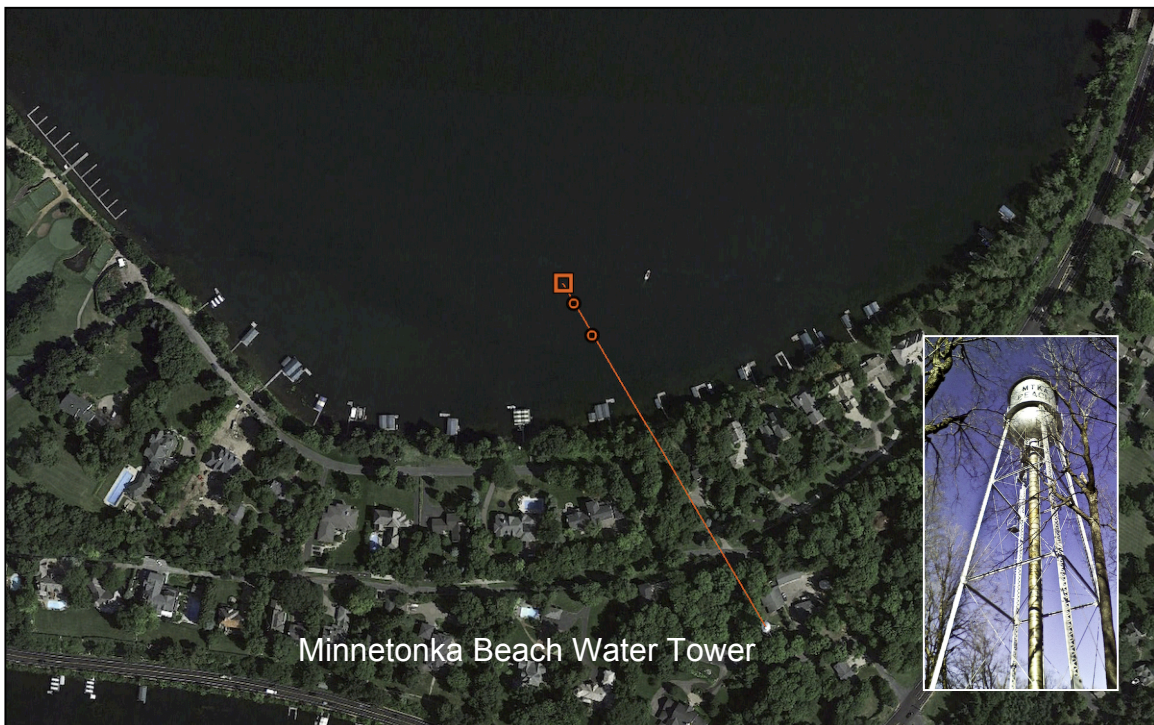
MHM plotted the coordinates of the Water Intake Pipe and Crib Site (red square) and the locations where the pipe appears out of the silt and goes back into the silt (red circles) in Crystal Bay. The red line connects the crib to the Minnetonka Beach Water Tower and lines up the water Intake, the pipe, and the tower (aerial photo from Google Earth). Insert: Minnetonka Beach Water Tower (MHM).

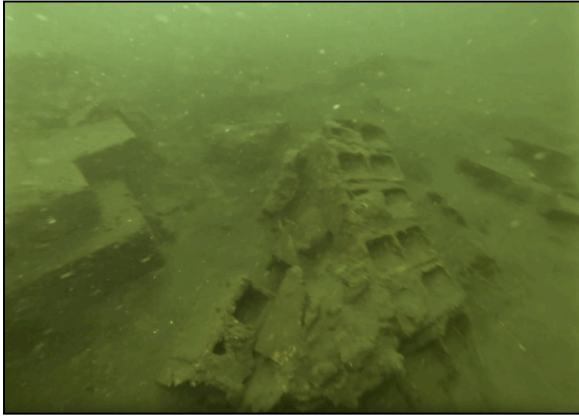
A view of the Rubble Pile from the dismantling of Big Island Amusement Park (Kelly Nehowig).

In September 2011, MHM recorded a sonar image of an irregularly shaped object off of the southeast corner of Big Island and it was labeled Anomaly 351. In mid-October 2015, Anomaly 351 was identified as a rubble pile, primarily comprised of hollow tile bricks reinforced with broken bricks and concrete. Some large pieces of wall are evident among single bricks or lumps comprised of a few bricks. Various bits of metal are located in the pile, along with a valve mechanism that is sitting up in the water column. The pile measures approximately 12 feet by 12 feet by 4 feet high. The type of bricks in the pile clearly indicates they were part of the buildings constructed for the Big Island Amusement Park in 1905-1906 by the Twin City Rapid Transit Company. The development of the park included the construction of Spanish Mission-style buildings, including a water tower, commissary, women's and men's dormitories, toilets, music hall, staff kitchen, pump house, ice house, boat house, and picnic kitchens. Many of these buildings had tile bricks reinforced with concrete as their foundations or their walls. The park opened on August 5, 1906. Ultimately, the Park was unprofitable, and it closed in late August 1911. The buildings and rides were mostly dismantled during 1918, with nearly all of the metal components recycled for use during World War I (*Minnetonka Record* 1906; Olson 1976, 202-203, 205; Construction Records: Ledgers, TCRT Records 1905-1909, 509, 513, 515-517, 519). MHM's archaeologists, volunteers, and kid students conducted brief terrestrial archaeological investigations on Big Island in 2003 and 2007 (Merriman and Olson 2007) and uncovered *in situ* examples of the architecture that matches the components found in Anomaly 351. MHM filed a Minnesota archaeological site form with the OSA in December 2011 and obtained a number (21-HE-402) for the Big Island Steamboat Pier, Park, and Veterans Camp Site at that time. In December 2015, MHM submitted a site form update to the OSA for the site and extended its boundaries to include the rubble pile. If more piles are located in the future, MHM can extend the site boundaries again.

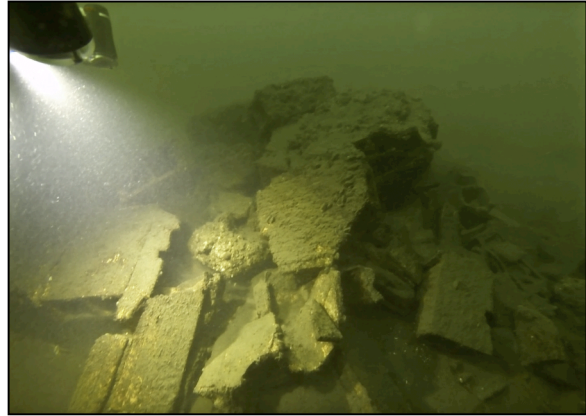
Another view of the Rubble Pile from the dismantling of Big Island (Kelly Nehowig).

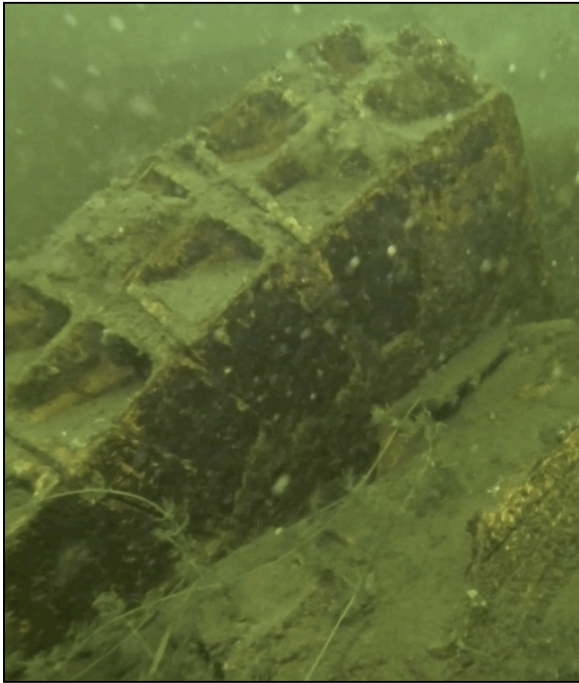
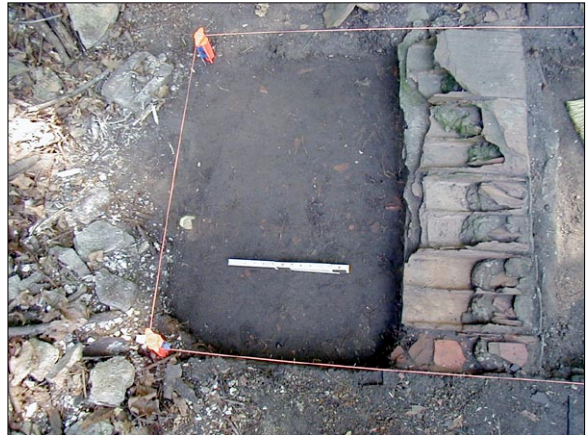
The Rubble Pile contains sections of intact Mission style walls. Shown above in 2003, MHM's archaeologists excavated part of the wall surrounding the roller coaster on Big Island. This test trench reveals an in situ section of wall that matches the construction of the piece on the bottom of Lake Minnetonka (Left: Kelly Nehowig; Above: MHM).

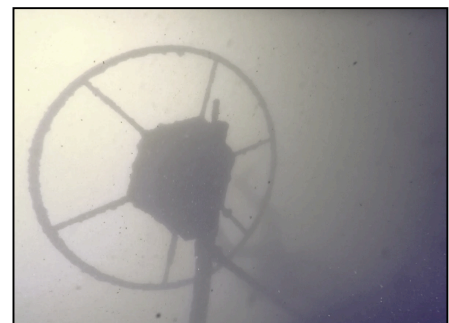
MHM's sonar image of Anomaly 7 and the Boat Lift's wheel (Mark Slick).

MHM recorded a sonar image of the Boat Lift Frame Site (Anomaly 7) during the LMS-1 Project in November 2011 and in early September 2015 identified the site. The frame is 10.50 feet long by 9.00 feet wide, sits 7.60 feet off the lake bottom, and is constructed of steel. The lift's boat bunks are extant and it has a manually operated winch drive train to raise and lower a watercraft. The lifting wheel is located in the water column and is movable. Anomaly 7 does not have a canopy frame attached to it, but it may have had one when it was attached to a dock. It may have detached from a nearby dock during high winds or it may have been intentionally scuttled.
